Phase III Investigations and Historical Study of the Spring Hill Plantation

LOCATION > Chesterfield County, Virginia

DATE > MARCH, 2015

Dutton+Associates, LLC

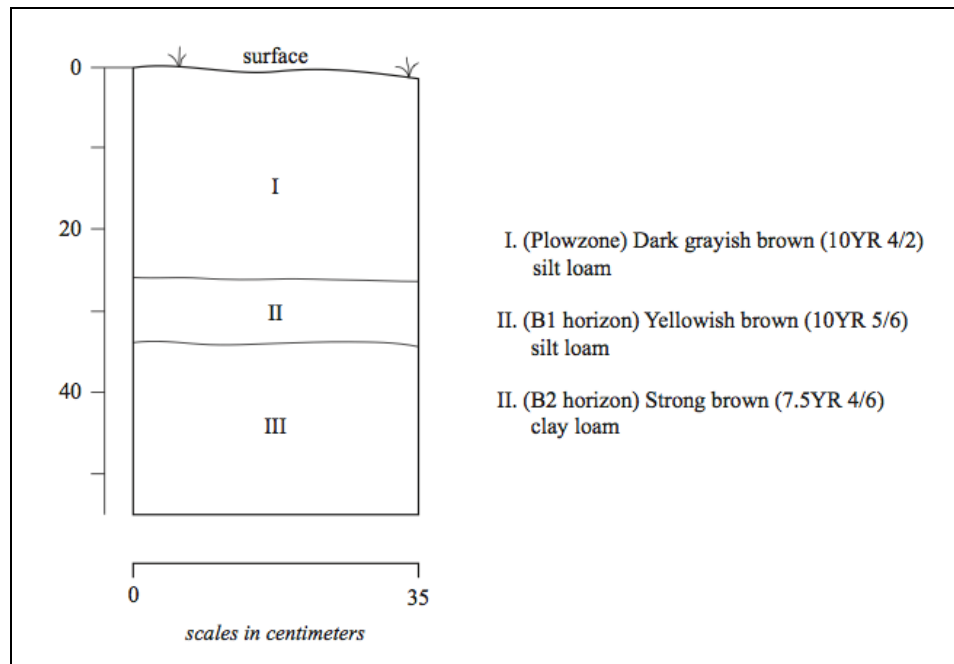
Figure 4-1. Profile of shovel test (123.7). (Source: Olsen 2010).

The Phase I and II survey report describes the stratigraphy within the Spring Hill Plantation site as typically consisting of plowzone (0–26 cm) of dark grayish brown (10YR 4/2) silt loam overlying a B horizon (26–34 cm) of yellowish brown (10YR 5/6) silt loam underlain by a second B horizon (34–50+ cm) of strong brown (7.5YR 4/6) clay loam (Figure 4-1). Descriptions of the stratigraphy noted during previous work suggest that the first B horizon is only located in some portions of the site and consists of a relict plowzone or transitional zone between the plowzone and the subsoil.

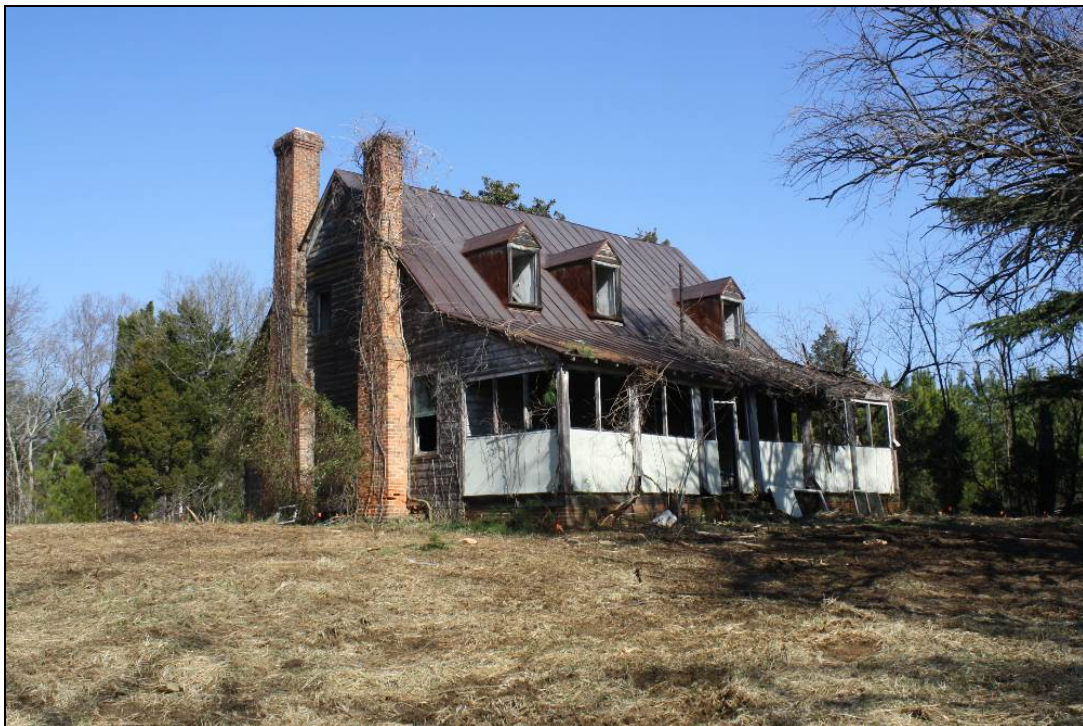
Figure 8-1. Spring Hill house, front and west side

The Spring Hill house in its current state is what can best be described as a wood-frame, one-and-a-half story, double-pile, side passage dwelling with double end chimneys and a two-story wing addition with a full-width front porch that spans the two blocks. Dendrochronology reveals that the original block of the building was constructed in 1767 and originally had a different layout consisting of one end chimney serving a full-width room in the northern half of the house, and an internal chimney serving two rooms in the southern portion of the house. Testing was not conducted on the wing or porch additions; however, construction details indicate they were likely added in the early-twentieth century at the same time as the reconfiguration of the original block to its current layout, likely circa 1905. The original block of the house measures approximately 7.9 meters (26 ft) wide by 9.1 meters (30 ft) deep. The wing addition measures approximately 4.2 meters (14 ft) wide by 6.0 meters (20 ft) deep and is set back only one foot from the front façade of the main block roughly nine feet from the rear wall. The full-width front porch extends out approximately nine-feet from the front facade. The building is oriented towards Proctors Creek, and therefore the front façade is to the south (Figure 8-1).

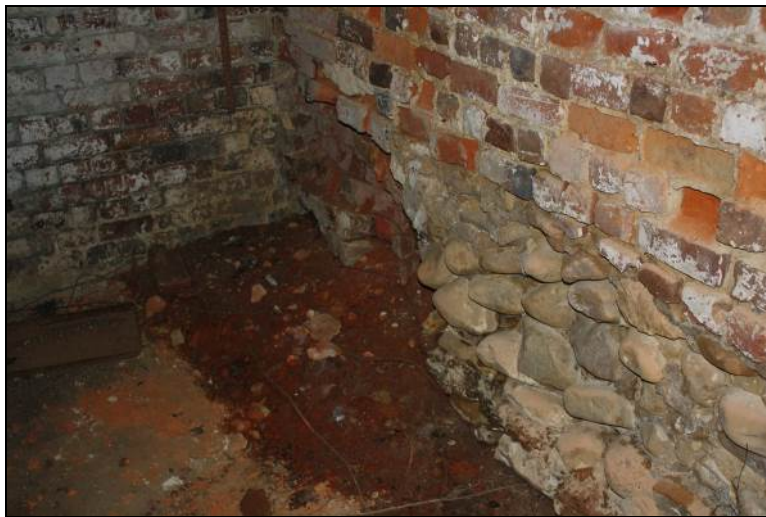
Figure 8-3. Cobbles in cellar wall

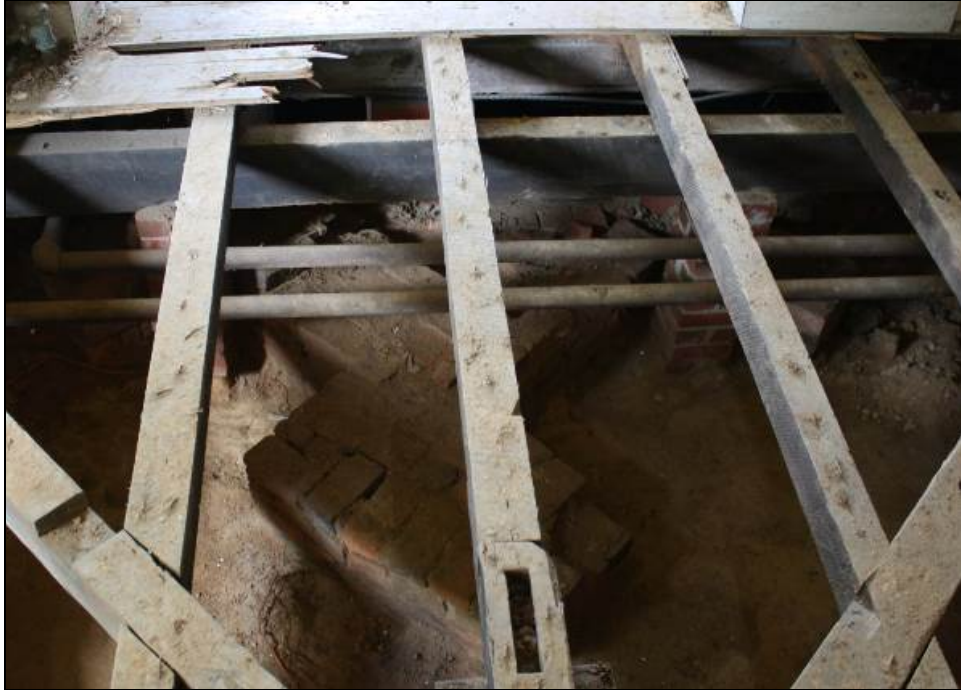
Figure 8-4. Original interior chimney base

piers, intermixed with the original chimney base and likely dating to the early-twentieth century, reinforce the floor framing over the crawlspace area that originally would have been tied into the internal chimney (Figure 8-5). These brick piers match the foundation of the wing addition and porch and therefore were likely installed contemporaneously to the construction of those additions, indicating the internal chimney was removed at the same time.

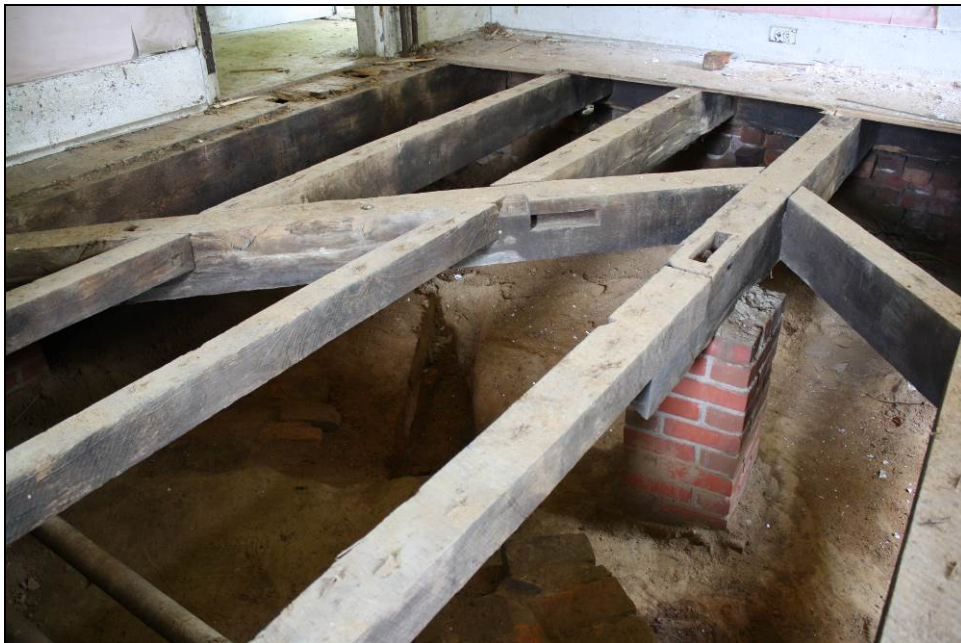
Figure 8-5. Brick piers reinforcing framing over removed internal chimney

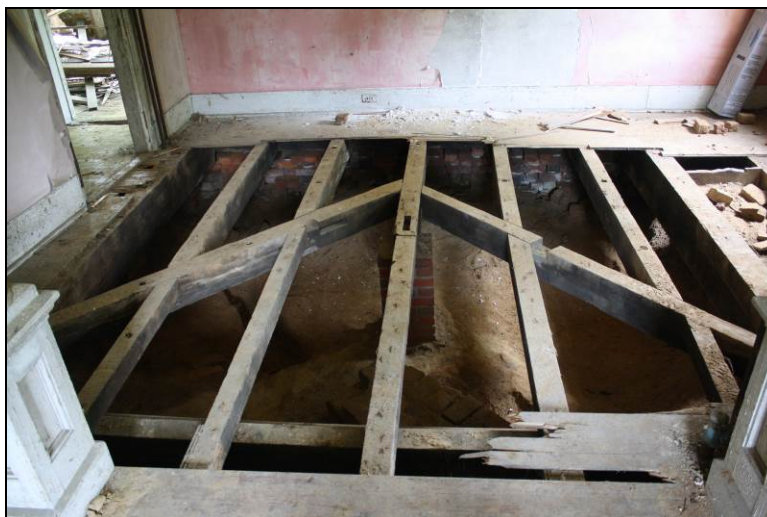
Figure 8-6. Dragon beams with later infill sub-joists.

The original block of the building is constructed of heavy timber frame clad with twentieth century beaded clapboards. At the base of the house are massive hewn pine sills set atop the brick foundation walls. The floor is framed by a series of heavy 15.2 cm (6 in) by 33 cm (13 in) hewn joists in the outer bays supported centrally by a pine girder on top of the brick partition wall. The joists have been notched down to just 22.8 cm (9 in) thick in the full-basement portion to allow more headroom. The floor framing in the central area of the building consists of joists that only span the half of the building above the full basement while the area above the crawl space is framed with a dragon beams that originally tied into the internal chimney and supported its hearths, but have subsequently been infilled with sub-joists to frame in the floor over where the chimney no longer exists (Figure 8-6). The walls are formed by heavy guttered cornerposts with down braces and two primary posts delineating the wall bays and to which the doors and windows are attached (Figure 8-7). Between the primary posts are a series of common studs. These posts and studs are topped by a heavy plate on which the roof joists sit. The roof joists, which also function as the second story floor joists, continue beyond the wall plates where the roof rafters tie onto them via a flat board falseplate, and form a boxed cornice on the exterior (Figure 8-8). The roof rafters join at the ridge where they are half-lapped. Collar beams on each truss form the attic floor/second story ceiling. Knee studs form the second story walls under the angled roofline (Figure 8-9). All of the joinery for the original framing is accomplished with mortise-and-tenon or half-laps, and are held together with a combination of wood pegging and wrought nails. The wing addition is built with balloon frame composed of dimensional lumber. The walls are set atop small sills and are supported by a system of common studs. Fasteners include a mixture of cut and wire nails. The exterior walls are covered with plain clapboards.

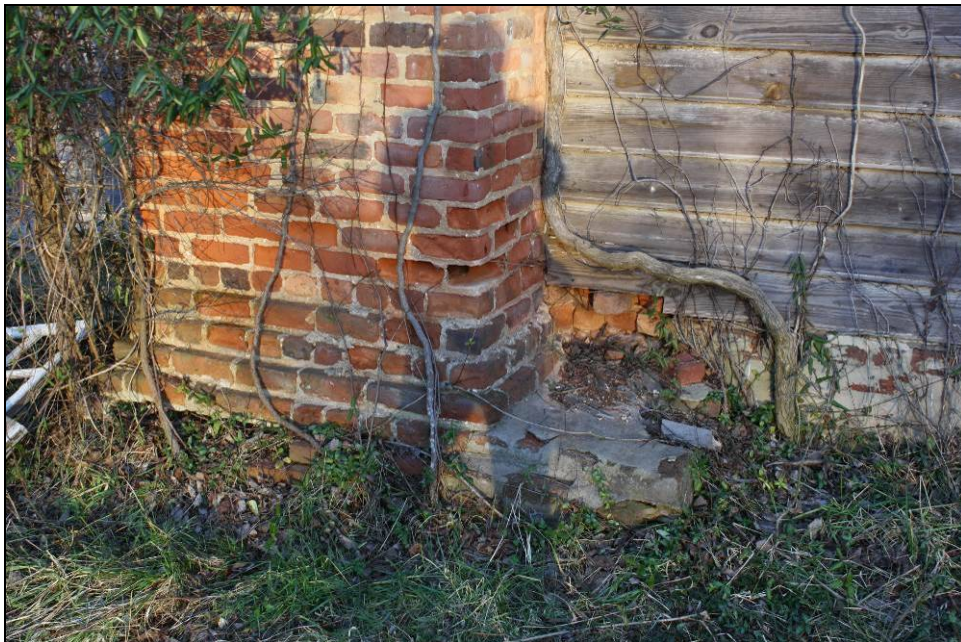
Figure 8-12. Southern end chimney with replacement stack over older base.

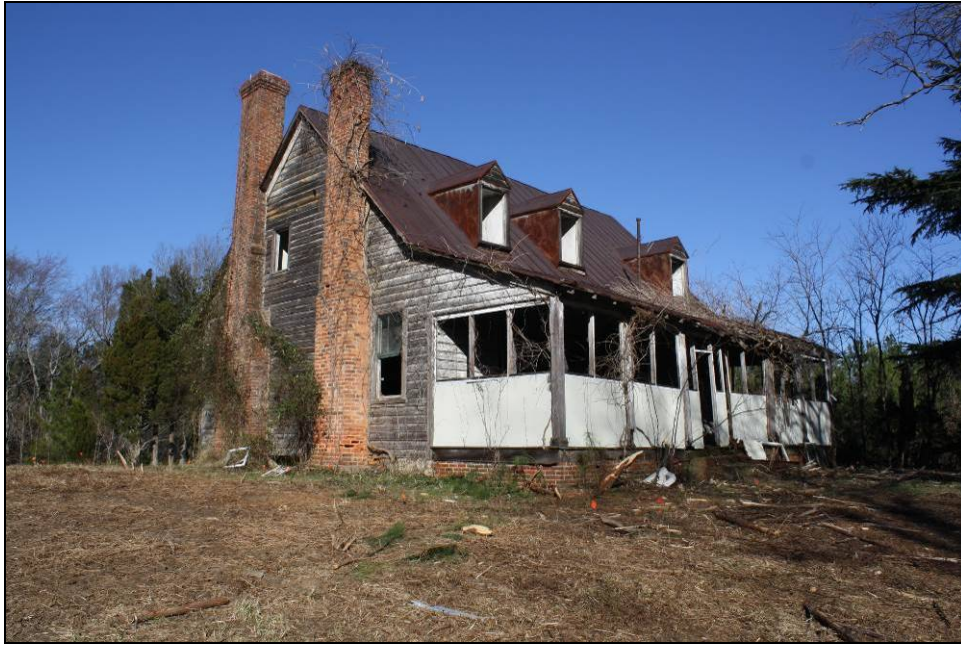
Figure 8-13. Full-width front porch.

A full-width porch set on a continuous pressed brick foundation stretches along the front of the building and was added contemporaneously to the wing addition (Figure 8-13). The porch has a wood floor with simple aprons that wrap around the foundation. It has been nonhistorically partially enclosed with foamboard kneewalls, likely in the 1950s or 60s, and was screened above the foamboard; however, all screening has been removed. An aluminum storm-type door provided access to the porch from a set of poured concrete steps. The porch is covered with a shed roof that ties into the front slope of the building just above the original eave, thus creating an integral roof, although the slope of the porch roof is slightly shallower than that of the house.

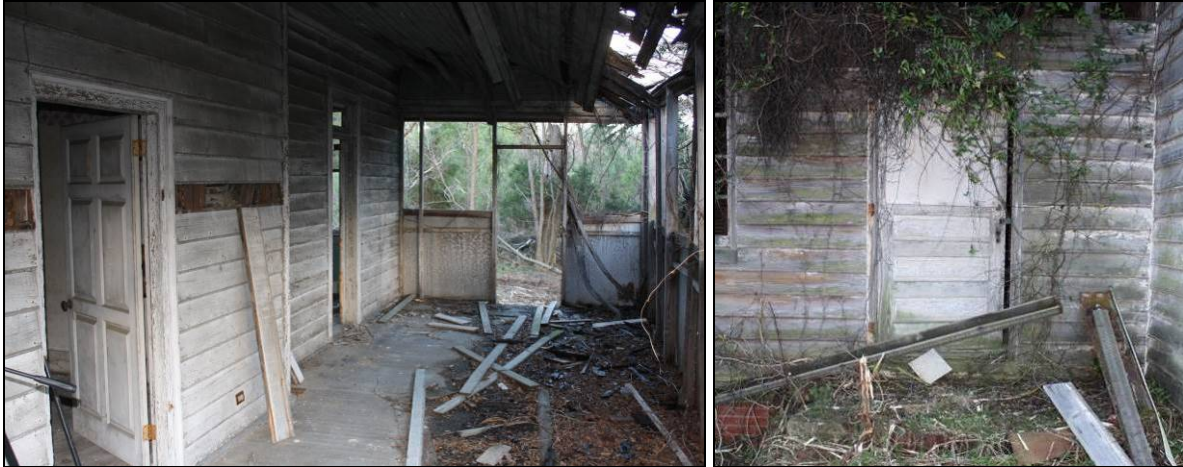
Figure 8-14. Front entrances (Left) and rear entrance (Right).

The front porch shelters two entrances into the house; the main entrance which is located in the eastern bay of the original block, and a secondary entrance set centrally on the wing addition (Figure 8-14). The main entrance consists of a single, six-paneled wood door set within the original pegged frame. The exposed frame has a beaded corner and functions as the architrave along with cove molding that has been added around its juncture with the later clapboarding. The secondary entrance into the wing has a single door with a large fixed pane of glass above three full-width panels. Above the door is a single fixed-pane, Victorian-type transom. The door and transom are set in a simple frame with flat board architraves. A third entrance into the house is located on the rear of the wing addition. This entrance is offset and approached by an open brick stoop that appears to be later than the addition. The door for this entrance appears to be mid-twentieth century with a single fixed pane of glass above three full-width panels. The door is set within a simple frame with flat board architraves. This rear entrance leads into what appears to have been originally an inset porch that was later enclosed. A fourth entrance leads into the basement from a bulkhead located between the two chimneys. This entrance holds a paneled wood door and is approached by a twentieth century concrete bulkhead with stairs.

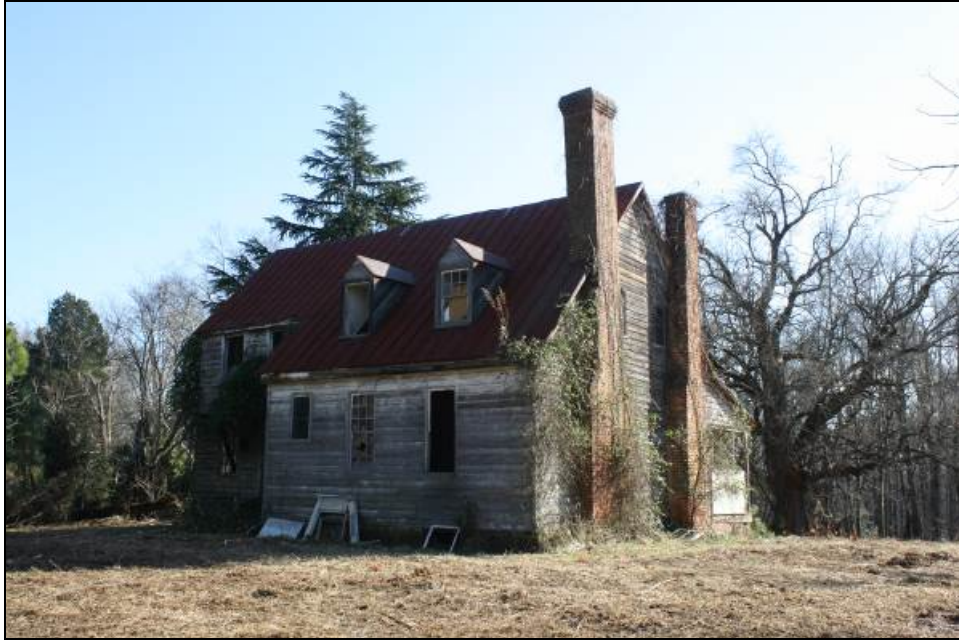
Figure 8-15. Fenestration on original block.

Window fenestration on the building consists solely of individual, double-hung sash openings. The windows on the original block are set within the original frames, but the sashes appear to be later replacements. The windows on the wing addition also appear to be replaced as they are identical in construction technique and muntin details to those on the enclosed inset porch, as well as those on the original block. Nearly all of the first floor windows have nine-over-nine light configurations with the exception of one small window on the rear of the original block that is six-over-six (Figure 8-15). The few second floor windows are all six-over-six. The original block has a single double-hung sash window located in the western bay of the front façade under the porch. There was originally a second window on this façade adjacent to the doorway, although it was later removed and covered with beaded clapboard. The rear façade of the original block is divided into three bays with two taller double-hung sash windows in the central and western bays and a shorter window in the eastern bay lighting the stair landing inside the house. The west side of the original block is pierced by a single window on the outer corner of first floor immediately adjacent to the replaced chimney. This window could not have been placed here until the current, narrower chimney was added circa 1925. It is possible this window was borrowed from the front façade under the porch and moved to this side location to allow more light after the full-width porch was added. The west side of the original block also has two smaller windows set between the two chimneys on the second floor. Fenestration on the north side of the wing addition consists of a single double-hung sash window adjacent to the rear entrance (one the enclosed inset porch) with two evenly-spaced windows on the second floor wall above. The east side of the wing has three unevenly spaced windows on the first floor (two one main mass and one on the enclosed porch portion) and no fenestration above (Figure 8-16). All of the dormers are later additions and hold double-hung sash windows with six-over-six light configurations. All of the window surrounds appear to have been replaced contemporaneously to the recladding of the house in the early-twentieth century. They are a simple flat board design with no trim or molding.

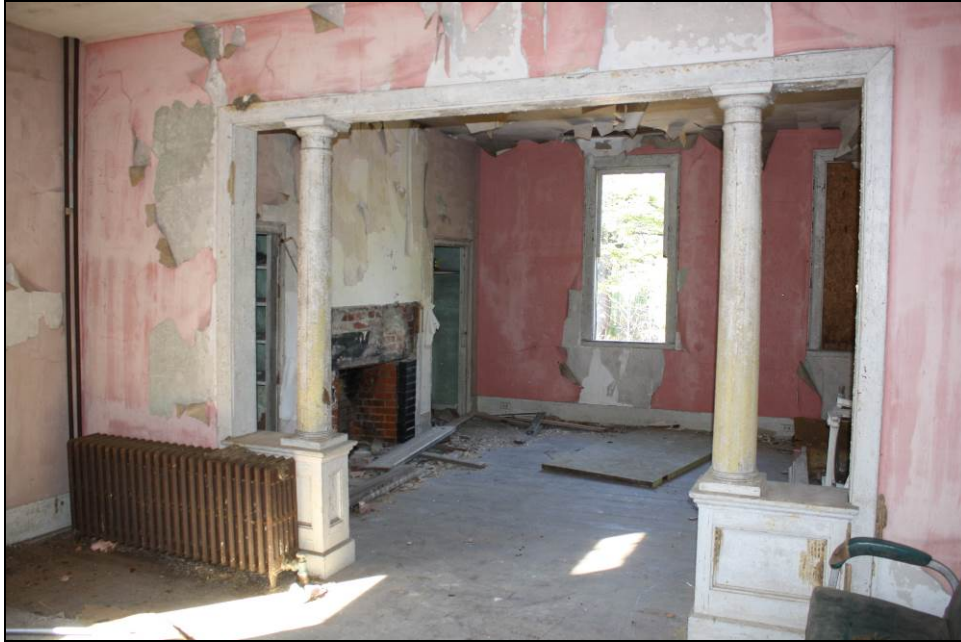
Figure 8-17. Partition wall with columns on knee walls.

In its current double-pile, side passage form, the interior of the building is two rooms deep with a hallway running the entire length within the original block. Both of the rooms are accessed from single doorways off the passage, and are divided by a central partition wall that runs under the ridge of the roof. Currently, the wall is pierced and the rooms are connected with a large central opening featuring Tuscan columns set on paneled knee walls that appears to be contemporary to the southern chimney replacement in 1925 (Figure 8-17). As evidenced by mortise holes in the joists under the floor in the passage, this partition wall stretched completely across the building in its original form. At that time, the north side consisted of a single room, heated by a fireplace flanked by closets on the end chimney (Figure 8-18). The southern half of the house was divided into two rooms at the internal chimney which abutted the central partition wall. The internal chimney had two angled fireboxes, one in the corner of each room. These rooms were connected by a doorway between the internal chimney and the front wall of the house, and connected to the northern room by a doorway in the central partition wall near the east side of the house. When the house was reconfigured in the early-twentieth century, the partition between the two small southern rooms was removed and a new partition wall was built from the front to back of the house to make the full-length side passage. Across this passage or hallway, the wing addition was attached and is accessed through a doorway off the passage. Within the first floor of the wing is a large room, likely a dining room that occupies the majority of the mass. A small room to the rear of this room was originally the inset rear porch, but was later enclosed to function as a kitchen, likely in the mid-twentieth century (Figure 8-19).

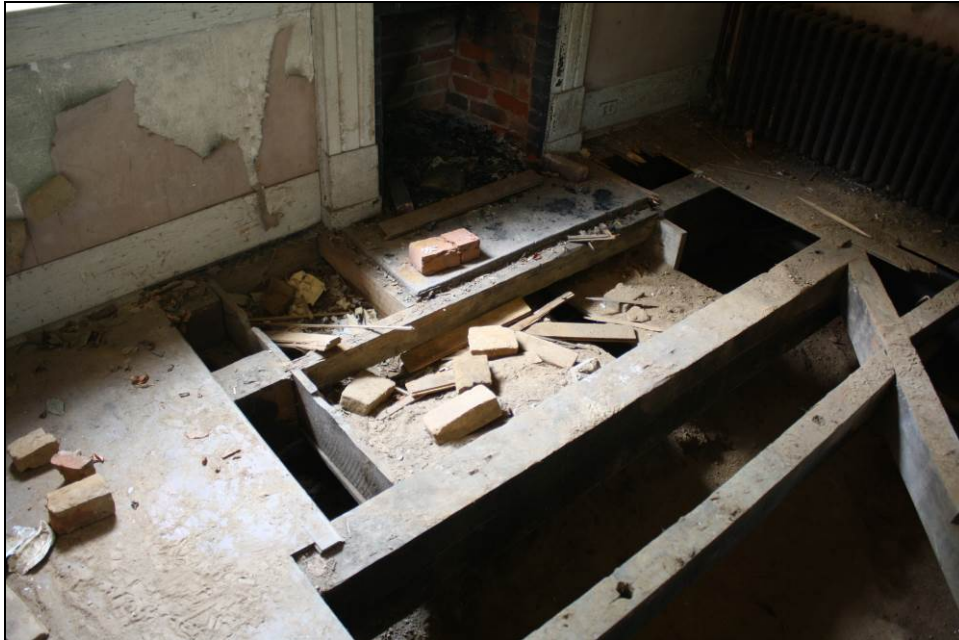
Figure 8-25. Hearth framing for first (Larger) and second (Smaller) southern end chimneys.

addition was installed to cover the floors after removing the internal chimney. When the end chimney built at that time was torn down roughly twenty years later in 1925 and replaced by a narrower chimney and fireplace, the gap from the smaller hearth was covered with narrow-width pine that was carried across the southern portion of the room (Figure 8-25). This narrow-plank floor was carried under the hallway partition wall and installed in front of the front door as well, likely to replace the floor just inside the door that may have had severe wear from over 150 years of dirt and sand being tracked in. Several courses of the narrow-plank floor were also installed between the two first floor rooms when the wall partition was opened in 1925. The floors throughout the wing addition are medium-plank pine. The floor in the enclosed rear porch kitchen is covered with asbestos tiles. The second story floors also reflect the various periods of renovation. The majority of the original block has original wide-plank floors although the gap where the internal chimney projected through is covered with medium plank floors matching the addition. The hearth from the first southern end chimney torn down in 1925 is infilled with narrow-width flooring.

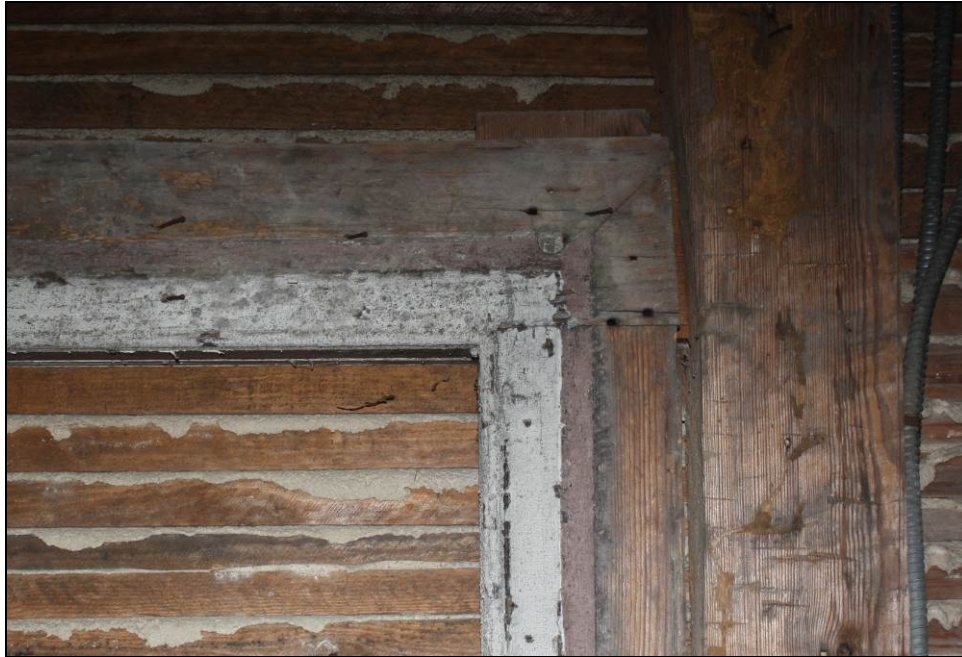
Figure 8-28. Detail of original pegged door frame.

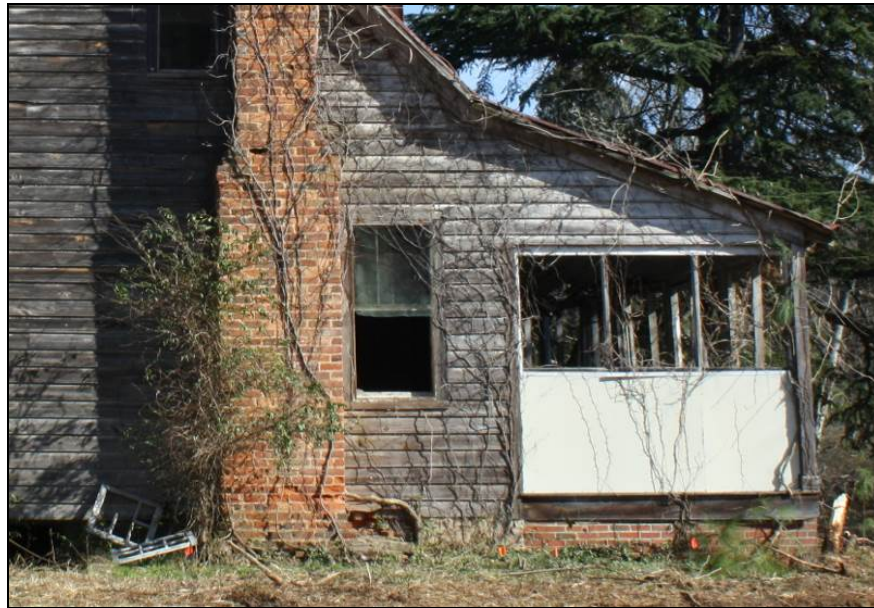
Figure 8-31. Window added to west side.

All windows appear to be in their original locations with the exception of one window added next to the replaced 1925 chimney in the front room of the original block (Figure 8-31). This window was likely relocated from the front (south wall) next to the doorway. The window frames also appear to all be original; however as stated previously, the sashes are replacements. The windows are minimally ornamented with only single tier cyma reversa molding around the edges of the frame, which are likely a mid-nineteenth century application. The windows in the original block sit on bullnosed sills atop a plain apron. The windows in the wing are ornamented only with plain board surrounds and sit on a square sill.

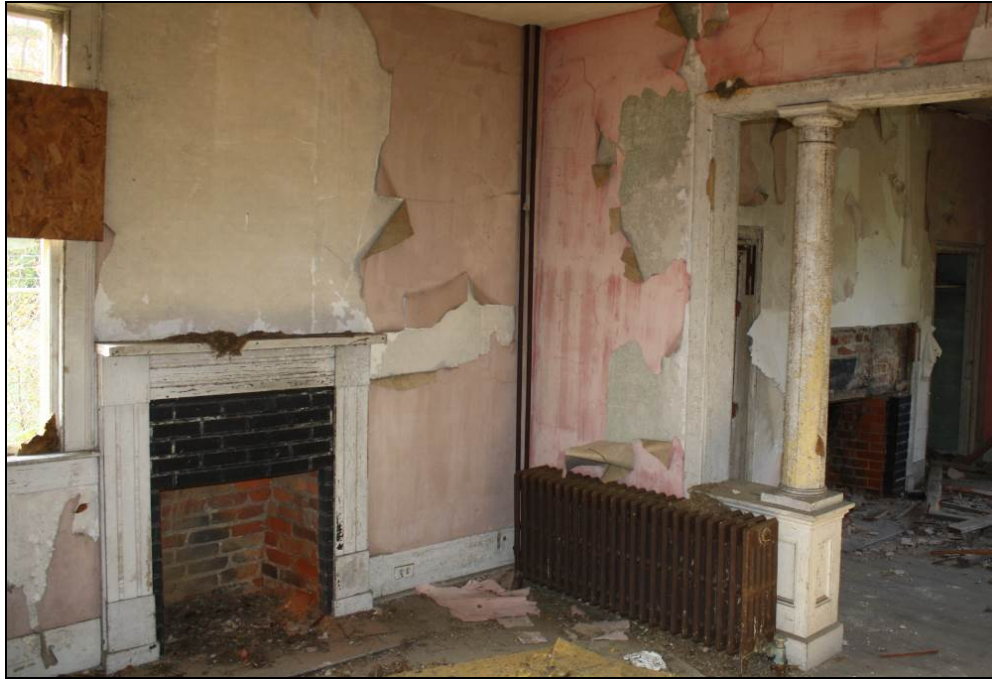
Figure 8-32. Matching fireplaces in first floor rooms.

Revival mantels consisting of fluted architraves, blank corner blocks, and a bull-nosed mantel (Figure 8-32).

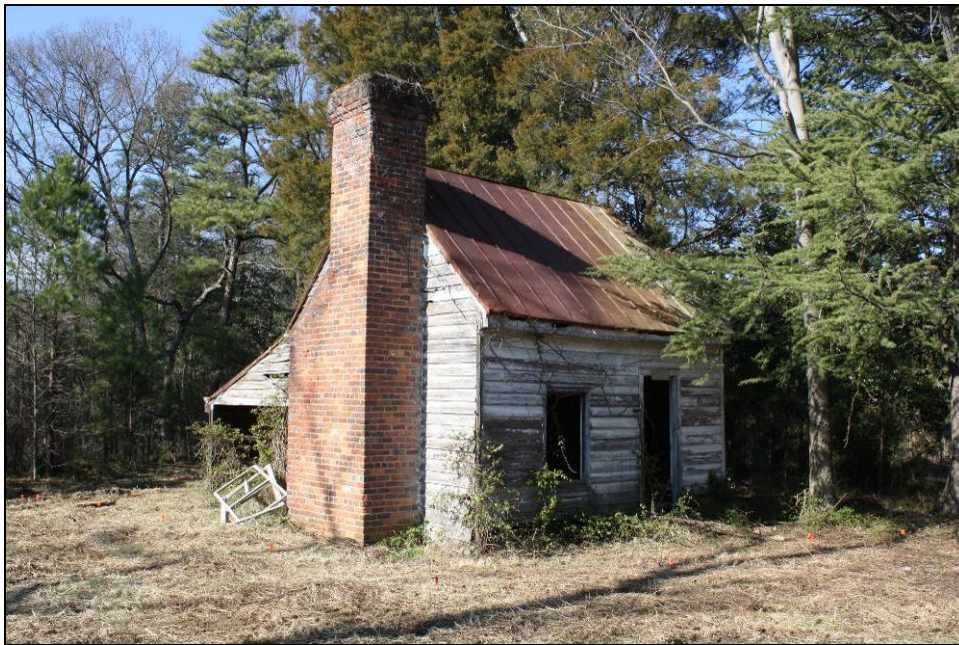
Figure 8-33. Reconstructed kitchen outbuilding.

In the yard to the northwest of the main house is an outbuilding that was reconstructed in the twentieth century (Figure 8-33). The exact date cannot be determined, however it appears to be from the second half of the twentieth century as evidenced by materials and construction techniques. The building seems to have been intended to lend the appearance of a nineteenth century kitchen with a large chimney stack. This small one room building is constructed on a continuous poured concrete foundation and has a dimensional lumber frame structural system with wood clapboard cladding. It is topped by a steep pitch side-gabled roof covered with standing seam metal. Fenestration consists of a single door and single window on the front (eastern) façade, a window adjacent to the chimney on the south side, and small windows on the second floor gable ends. All of the window sashes have been removed. The building features a large brick chimney on the south side with a single brick shoulder inside the gable. It is set on a heavy concrete base, and is laid in an irregular English bond ranging from six to eleven courses of stretchers between rows of all headers. Above the shoulder it transitions to all stretchers and is capped by a six-course corbeled capital. An enclosed shed is appended to the rear of the building, although appears to be original from the continuity of the foundation.

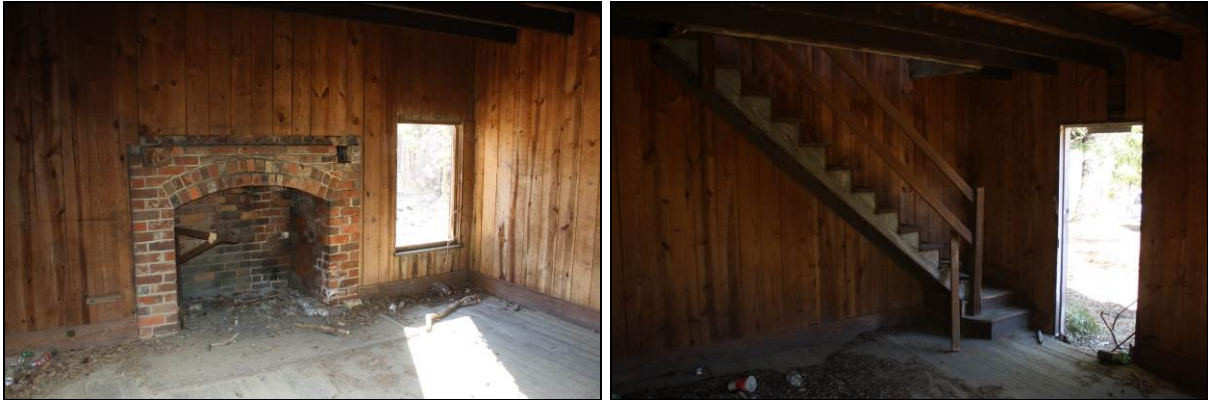
Figure 8-34. First floor fireplace (Left) and stairs (Right) in the kitchen outbuilding.

a “period” building. A narrow flight of steep dogleg stairs in the front corner provides access to the attic above which has a wood floor, but is otherwise unfinished (Figure 8-34).

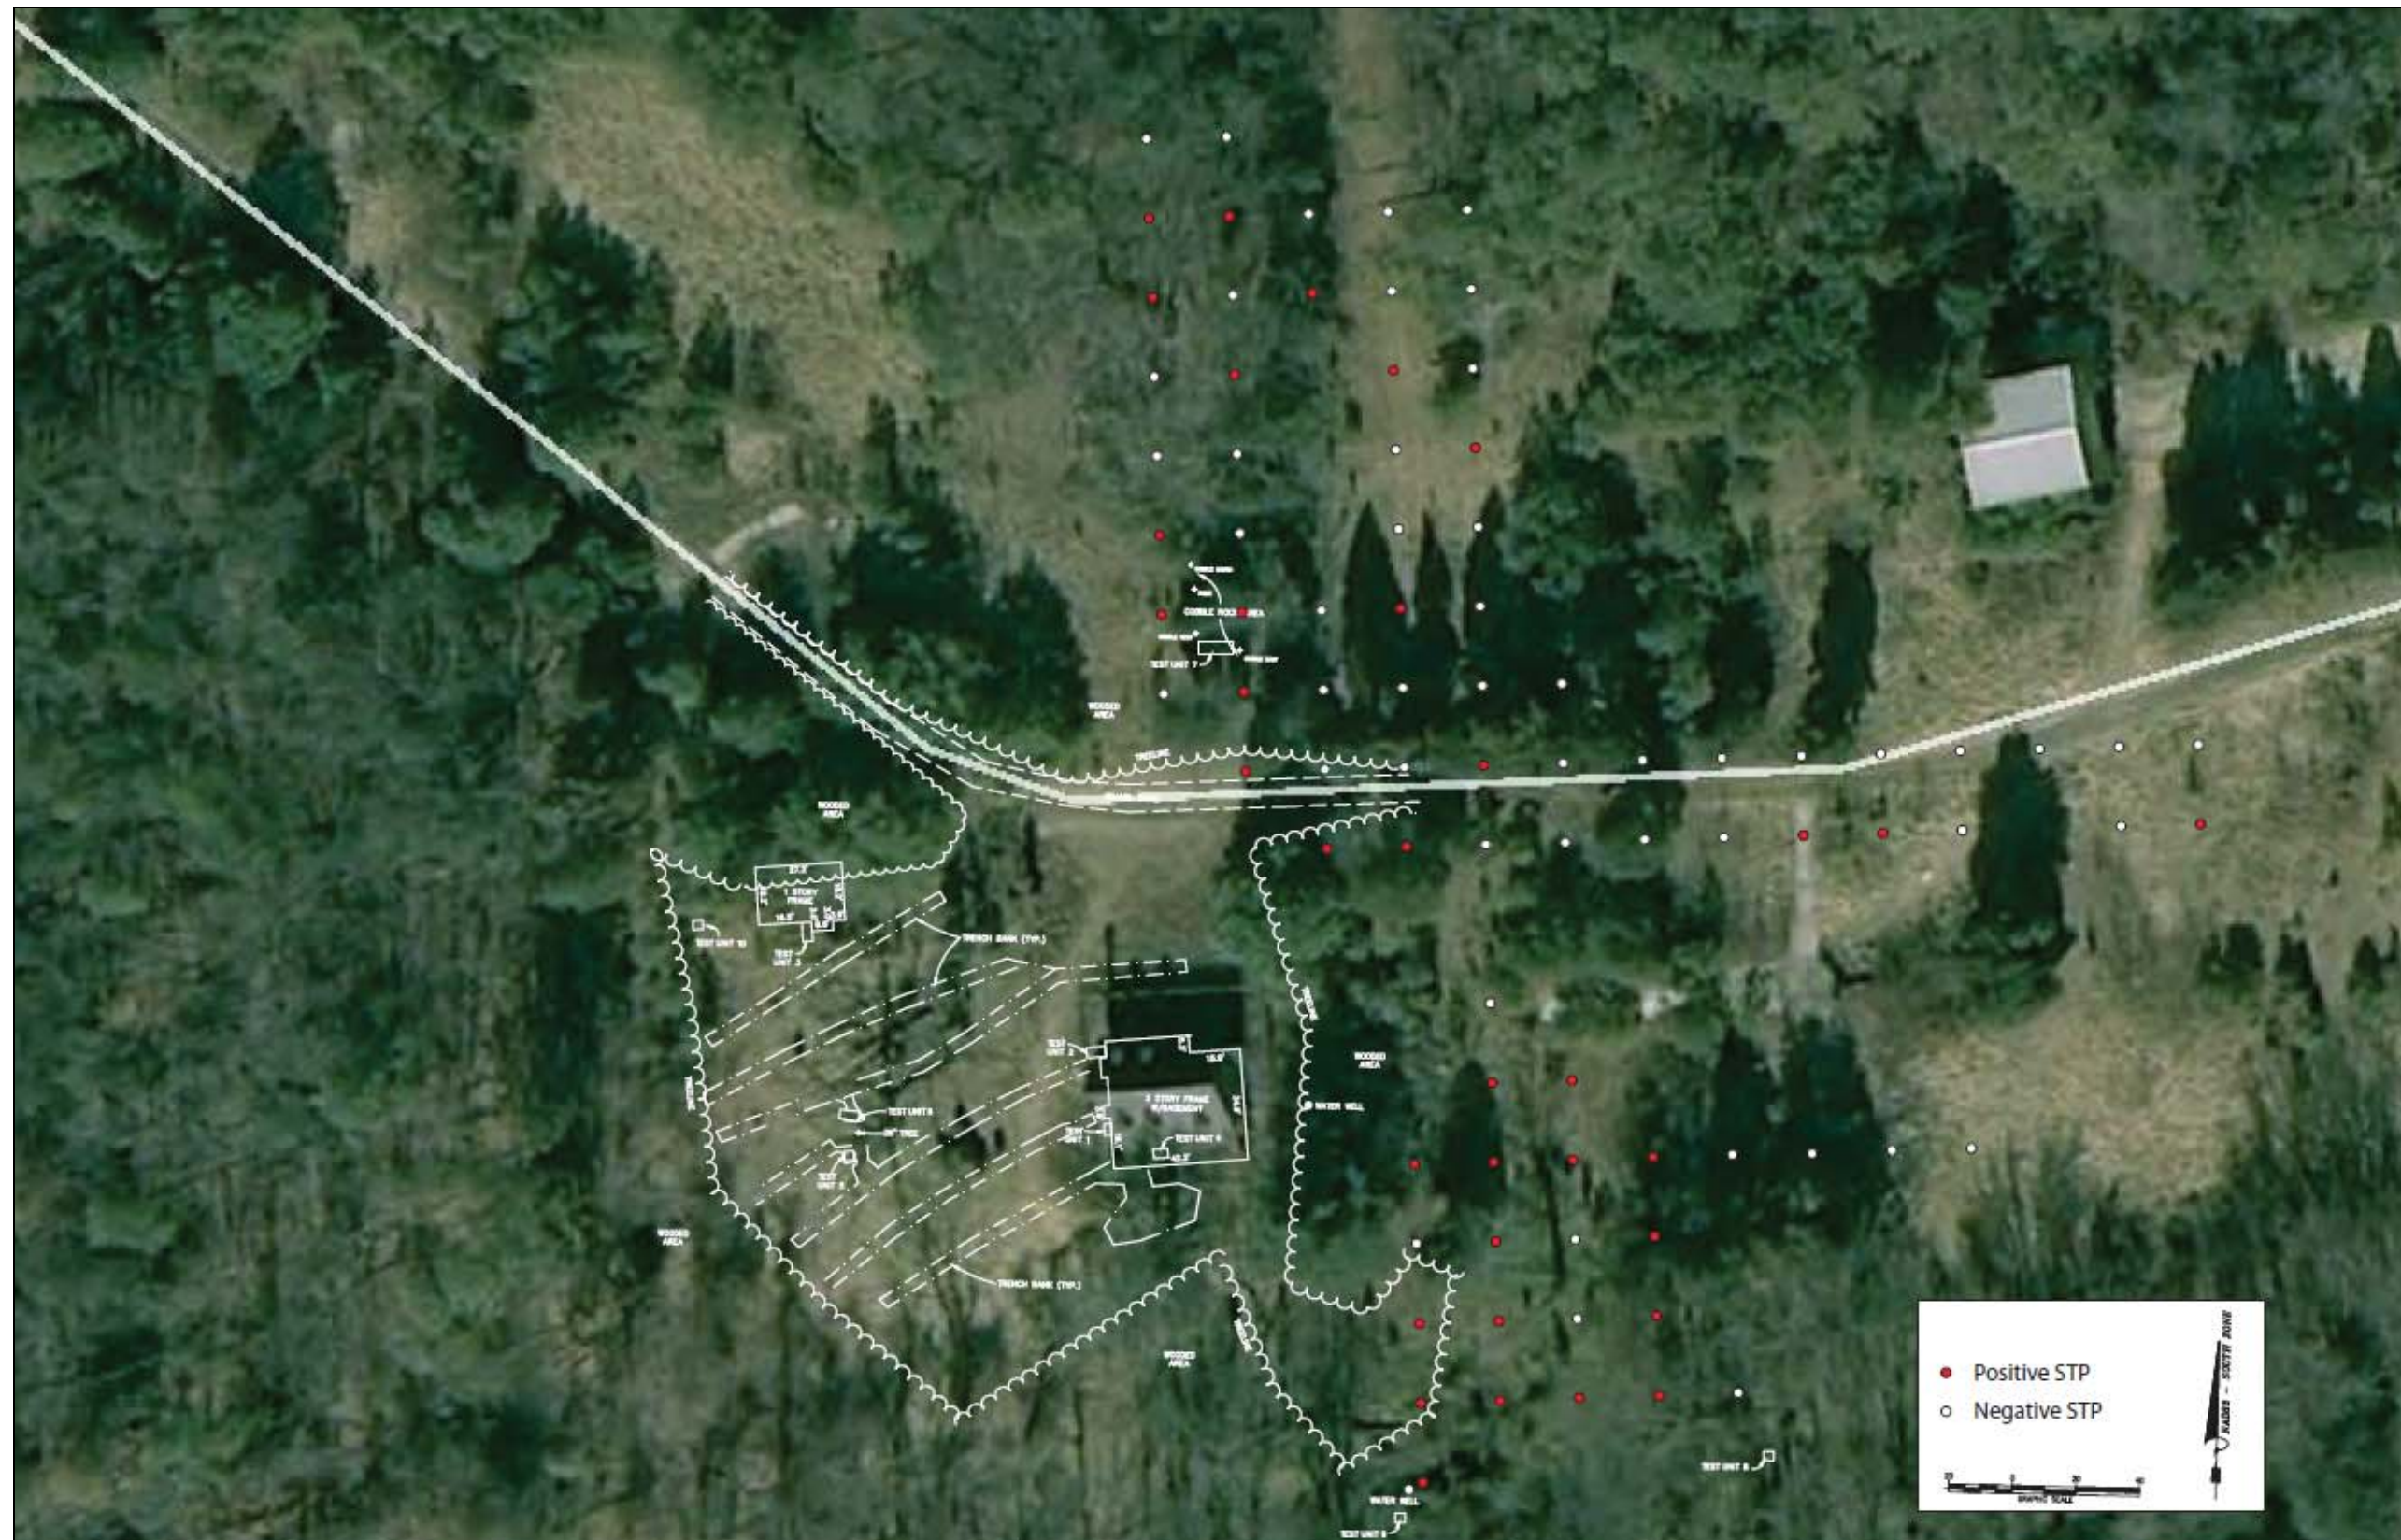
Figure 8-35. Aerial view of data recovery excavations illustrating locations of trenches, test units, and shovel test pits.

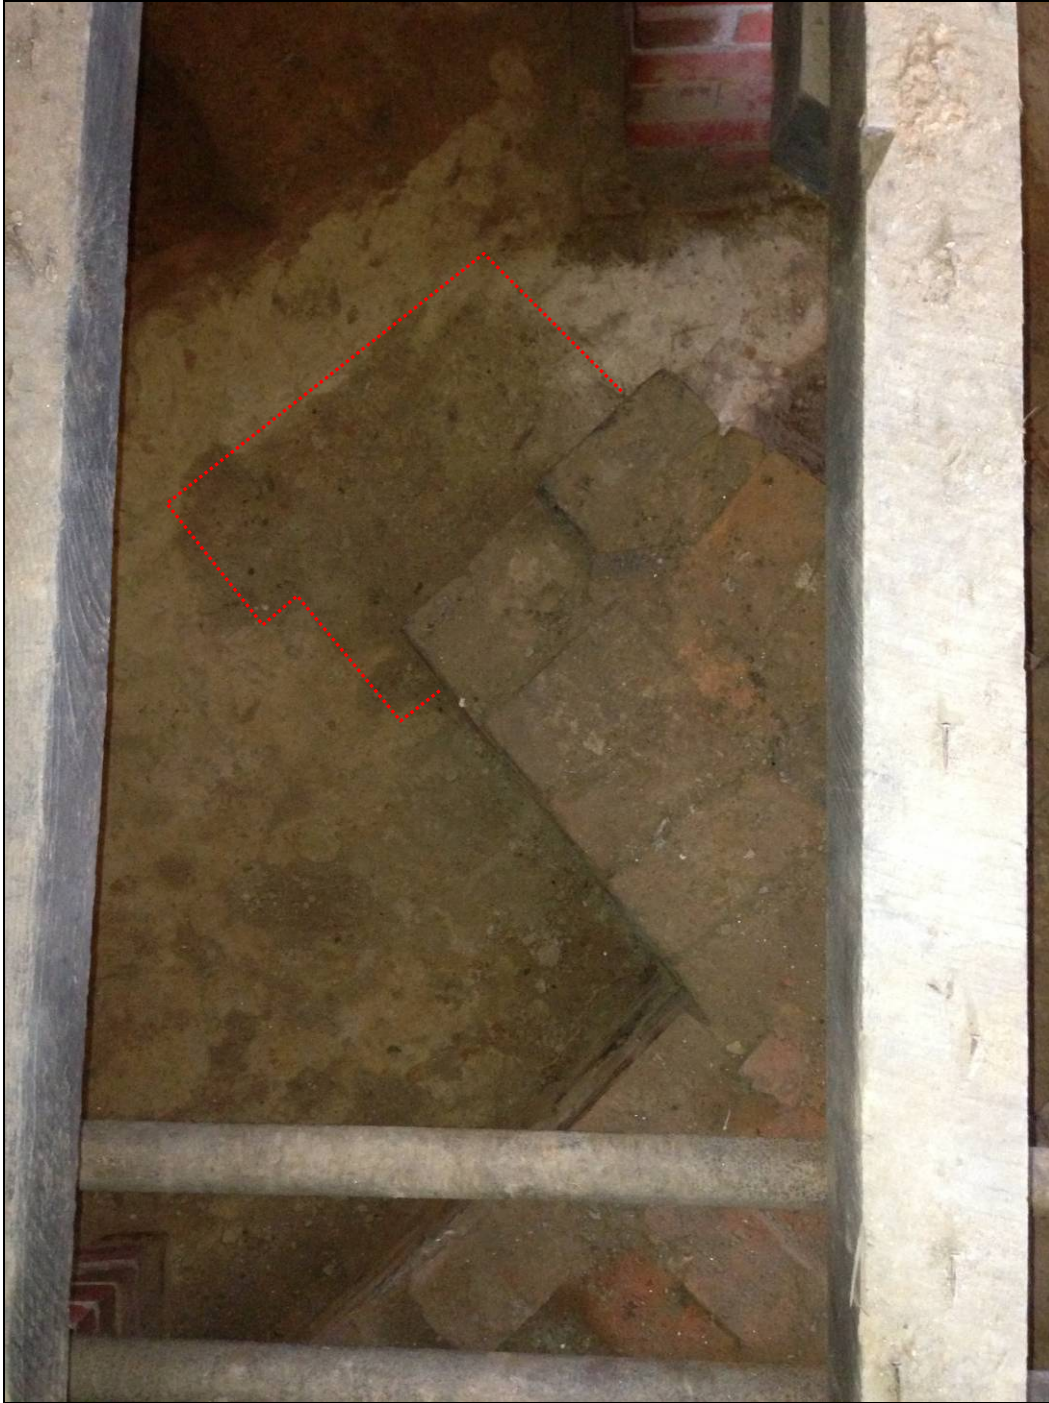
Figure 8-37. Plan view of Feature 45.

Immediately adjacent to the brick chimney base, a dark brown (10YR3/3) extremely loamy soil was visible. The feature measured approximately 27cm (0.9 feet) by 24.3cm (0.8 feet) (Figure 8-37).

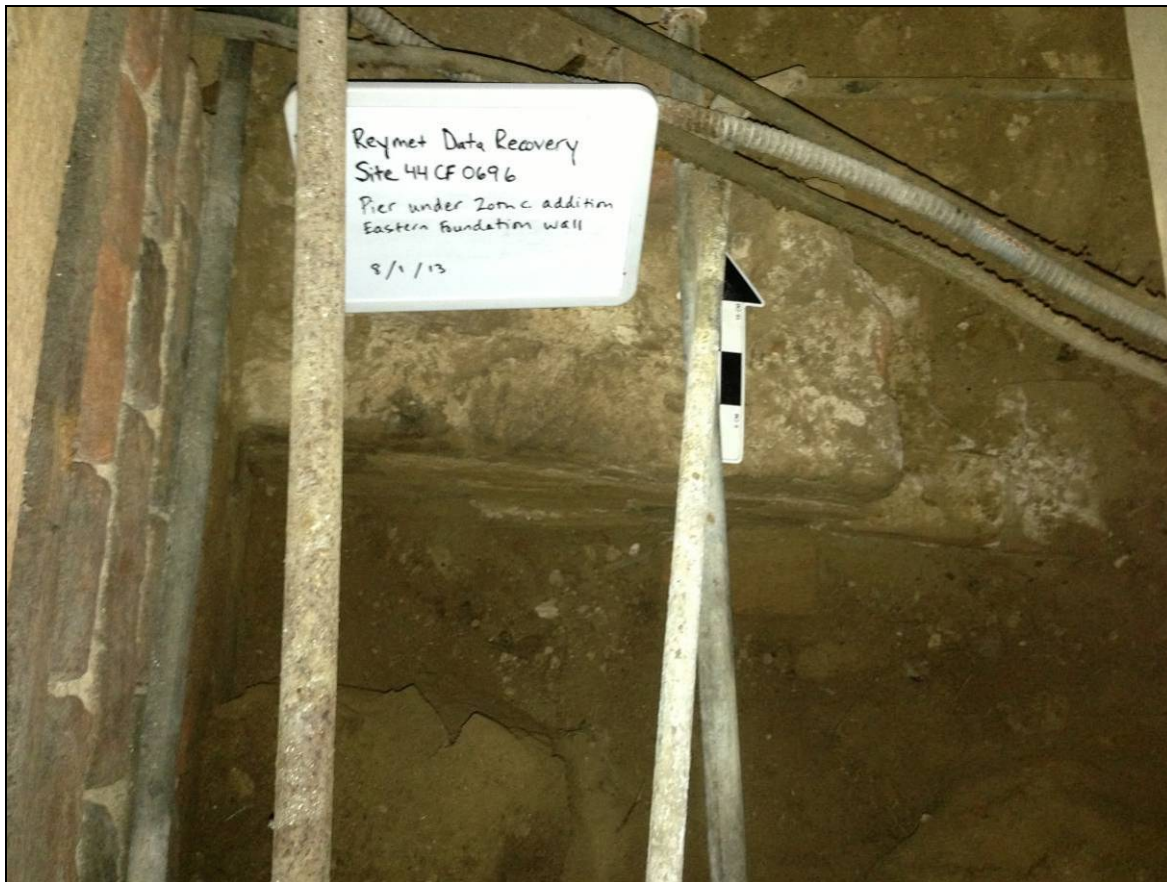
Figure 8-39. Wing wall east side of house.

Once the area was somewhat exposed, a section of a brick wing wall or pier was visible abutting the original foundation of the building (Figure 8-39). This articulated section of brick would have served as a support for stairs leading to the entry door. Only the brick on the southern side of the door was accessible due to the piers for the addition, but it is likely that another wing wall or pier would have been located on the other side of the door.

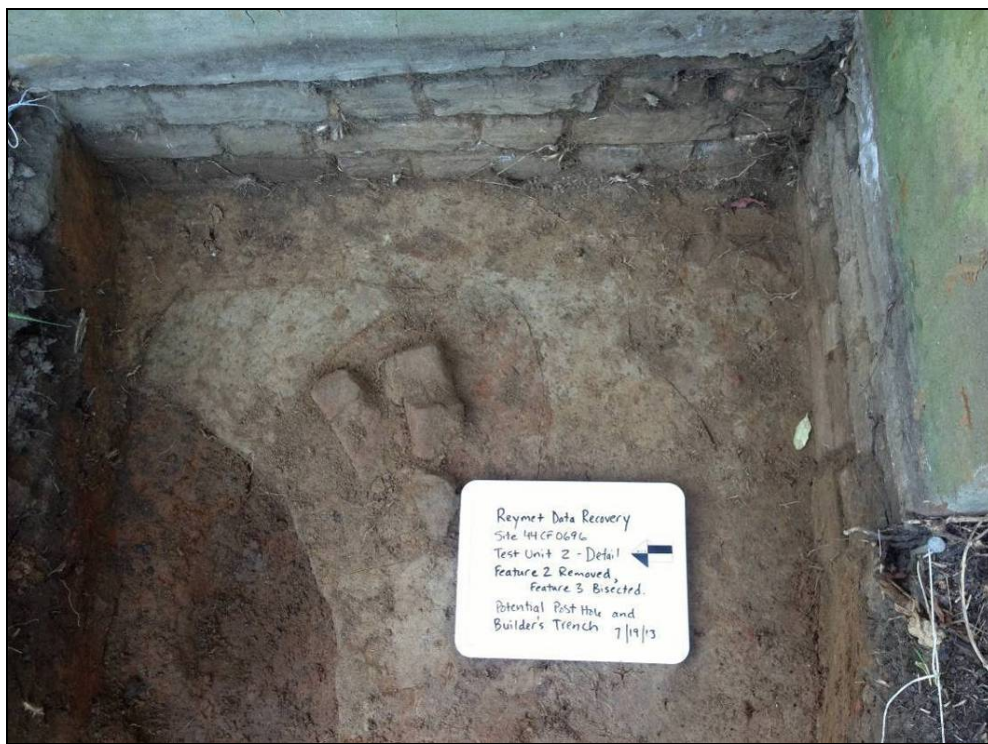
Figure 8-44. Plan view of Test Unit 2 with detail of Feature 2 removed and Feature 3 bisected.

Once Level B, which consisted of (10YR5/2) silty clay loam was exposed, two features were identified in the test unit. Feature 2, in the northern portion of the test unit and Feature 3, a trench-like feature in the western portion of the test unit and cut by Feature 2. Once Feature 2 was removed and Level C was exposed, an additional feature, Feature 44, was visible. Level C, subsoil, showed evidence of standing water and had gley characteristics. It consisted of mottled (10YR3/6) and (10YR5/1) soils (Figures 8-44 and 8-45).

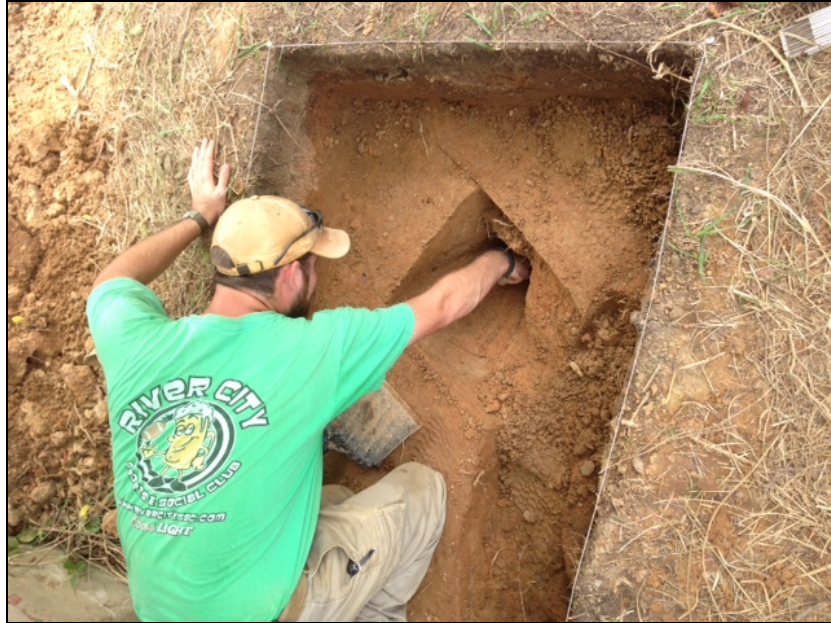
Figure 8-47. Excavation of Feature 3 in Test Unit 2.

Feature 3 consisted of a linear feature of dark yellowish brown (10YR4/4) very silty clay loam (Figure 8-47). Only one nail fragment was recovered from the feature, making its interpretation difficult. Based on its location, soil texture, and shape, it is possible that the feature is related to drainage issues at Spring Hill and that it served to draw rainwater away from the foundation.
